INFO SHEET

Rust stains and pool resurfacing

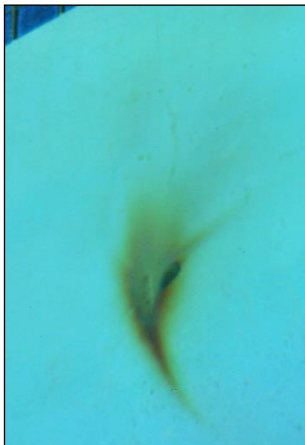
General surface rust stains

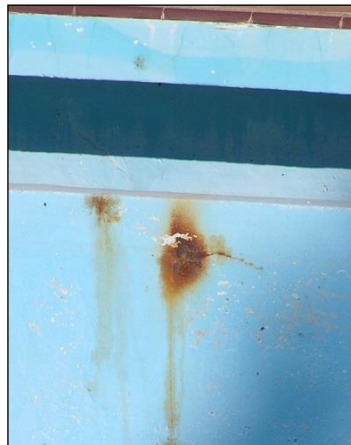
Crack with rust stains.

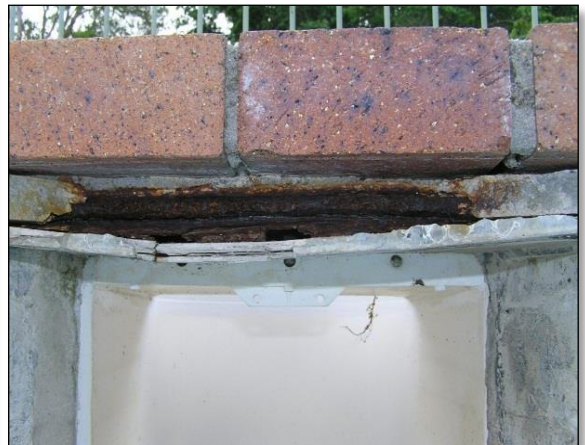
Check the metal plate above skimmer box

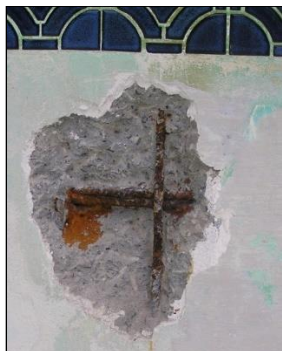
*What you may see once you start digging into the rust spot. On closer inspection it can be seen that the rust is all around the steel and the concrete needs to be dug out completely and rusty steel exposed on **ALL** sides. Vital!*
