INFO SHEET

Understanding Surface Defects in Swimming Pools

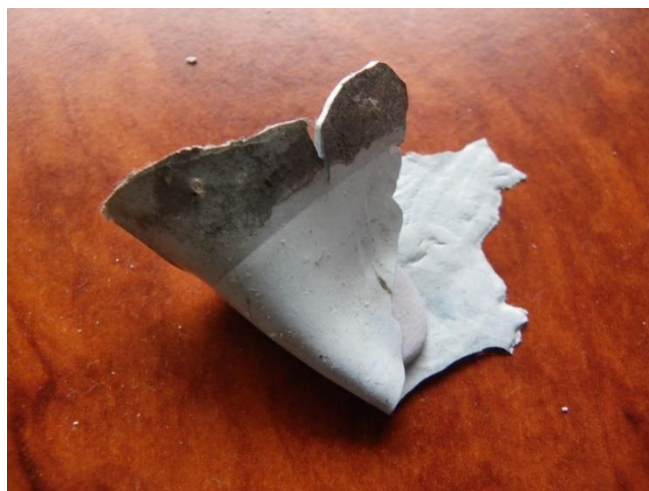
1 An unclean surface is usually the result of insufficient surface preparation and coatings will not adhere well (or at all) to such surfaces. Oils are especially bad as they tend to prevent adhesion as does a silicone treated surface. The coating will tend to come away cleanly leaving a smooth bright surface on the underside. It may also have some mold or dirt attached, showing how poorly the surface was prepared. There may be a few particles of the surface attached as well, but in generally not many. (See pic 1). A thoroughly clean, oil, dirt and grease free surface is the only answer.

2 Very smooth surfaces may be too smooth to allow a good mechanical bond to the surface such as getting paint to adhere to glass. It can also happen with highly polished mineral surfaces, though usually by their very nature they are still quite rough at a microscopic scale and allow for adequate if not good adhesion. It is far better to roughen (etch) such surfaces before coating. (See pic 1)

Pic 1. Paint sample showing a “clean” underside indicating insufficient adhesion due to poor surface preparation and also mold present.

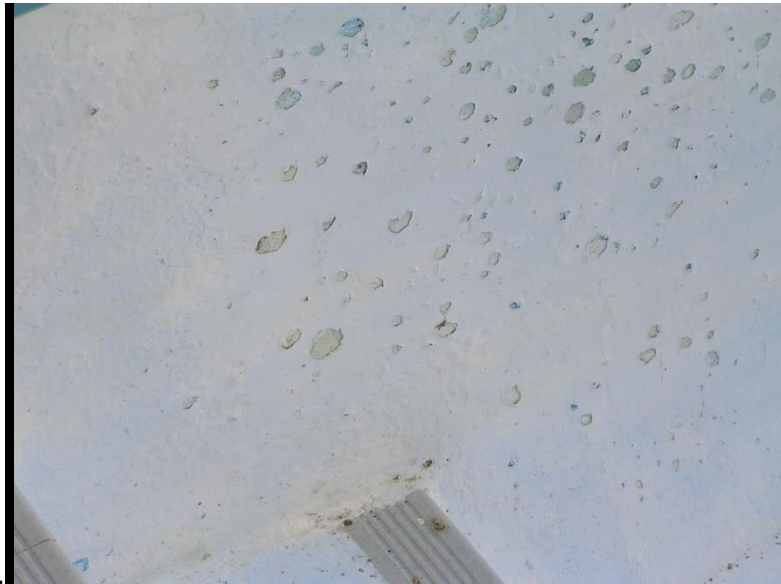
- 3 Water pressure (Hydrostatic) can be an issue when a coating is applied to any porous or semi porous surface. Such as when water is behind or underneath the coating, as in ground water outside a swimming pool shell. This includes concrete (which is generally not completely water or vapour proof), Marcite, Pebble Tec and plastered - rendered surfaces. A surface that has a worn coating or one with a thin coating may be subject to hydrostatic water pressure yet show no symptoms of such. This is because the coating is so in- effective and worn that any water pressure simply causes the water to slowly pass through the coating without damage to it. However, when a new coating is applied such as and Epoxy or Fluoropolymer it presents a waterproof coating and also one with a very low ability to pass water vapour through it. Thus, the water pressure may now exert sufficient pressure to cause the new coating to blister or bubble and there by fail. Such results are often seen within 6 months of the pool being refilled and more often than not on walls that face the west or north. (See pic 2) The coating may fail at the surface as in pic 1 or cause the substrate to fail internally as in pic 3. Picture 1 is essentially an adhesion failure and picture 2 a cohesion failure within the substrate. Determining if a pool will be subject to hydrostatic pressure is not always easy, but by considering location, its environment and testing for hydrostatic pressure or trapped water (see Application Notes and below) this can be usually determined in advance and measures taken to reduce the prospect.

Pic 2, showing blisters (broken) as the result of Hydrostatic pressure.

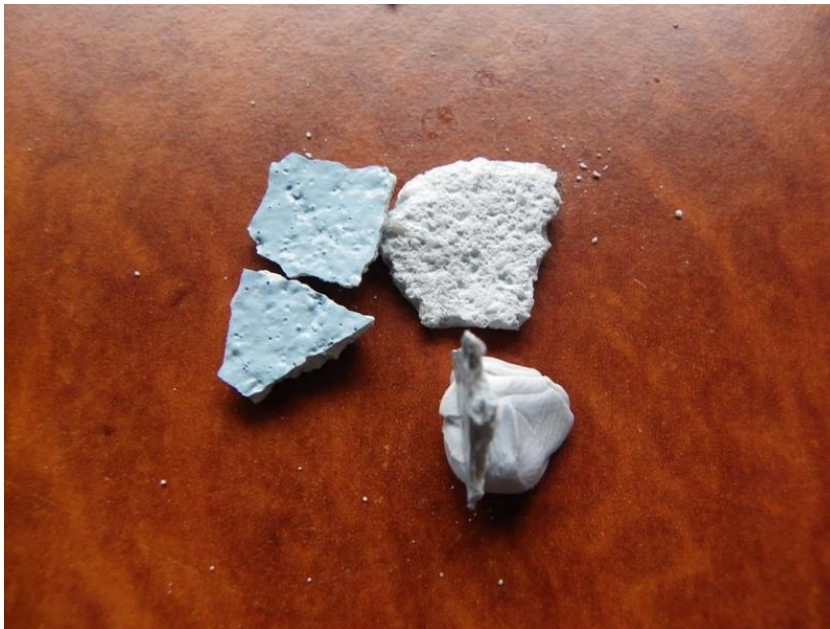
- 4 Failure of the substrate can happen if the substrate is in a poor or weakened condition. This is usually not always apparent at the time of application as one cannot see into the substrate, nor know about its application conditions or life history. This may include incorrect application conditions, mixing or curing of the substrate, poor chemical balance of the pool water and many other unknown factors during the life of the pool. All of these can determine how well the substrate performs after the coating is applied. If there is any weakness in the substrate, then it may fail within (Cohesive failure) and the coating will come away with some of the mineral substrate still attached (See pic 3). For areas of the substrate that are drummy, one can tell these before any coating applications, they need to be repaired before painting. Thus, only the surface presented at time of application can be seen and any internal weakness cannot be foreseen, nor be accepted by the coating contractor.

Pic 3. Showing underside of paint sample with, in this case Marcite attached. Here we see a weakness, basically a cohesive failure of the Marcite to the substrate. Bottom right sample is edge on, showing cross section.

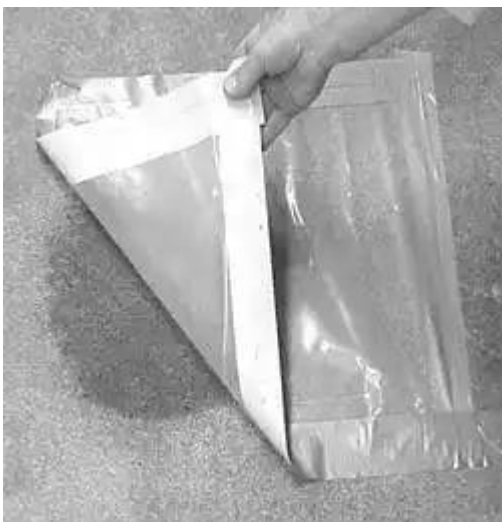
Pic 4 Checking the substrate to see if moisture present, which in this case is. You can see the dark moist surface. Also, there is likely moisture droplets on underside of the plastic sheet. Allow substrate to dry completely if in doubt.

To check if sufficiently dry, tape a piece of clear polythene sheet (15 ins x 15 ins) and leave for at least 16 hours. Do this over several areas of the surface. If there is moisture (droplets) on the underside of the plastic sheet, then it indicates there is too much moisture for good adhesion. Allow pool to dry out before application.
