INFO SHEET

Discussion about Marcite pools and upgrading with a Hi Performance Fluoropolymer Coating.

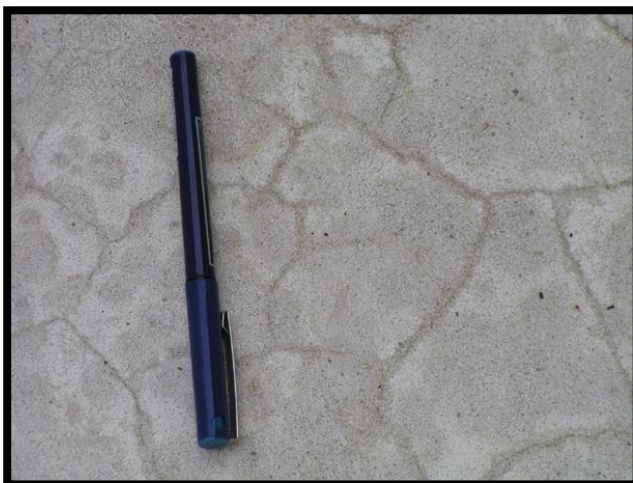
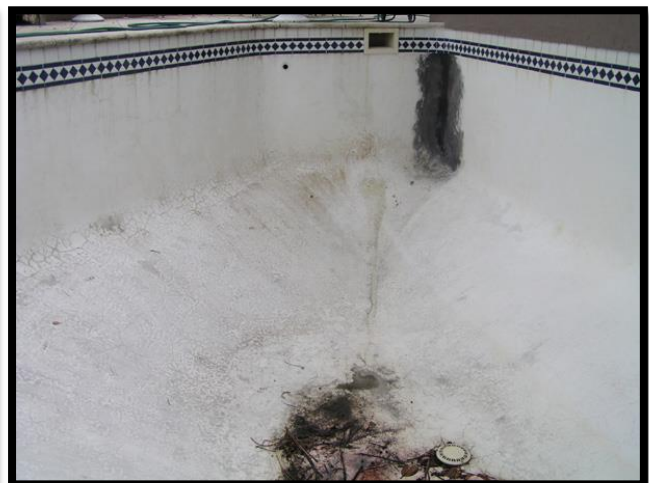
Over the years and depending on the quality of installation, pool water chemical balance and general wear and tear, it will slowly degrade. Usually is ends up with random cracks, worn areas, black staining and may be rust staining too. There can be large areas where the Marcite is soft and weak. Some areas may be drummy (hollow underneath) or break away completely. There may be white calcium build ups as well.

Older pools often become hard to keep clean, with algae attacks common and particles of Marcite getting stuck in filters.

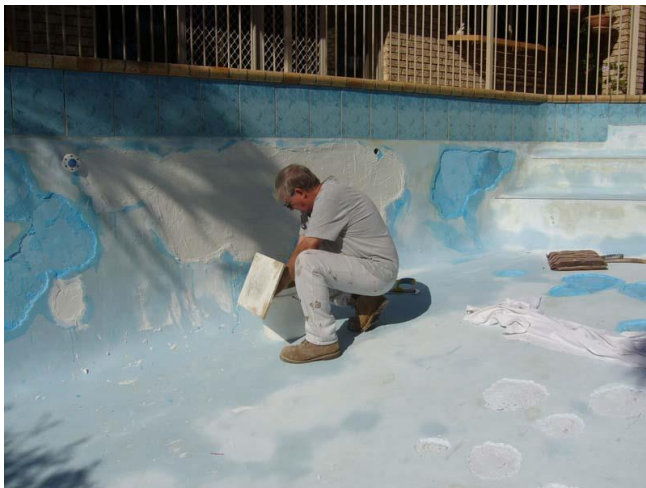
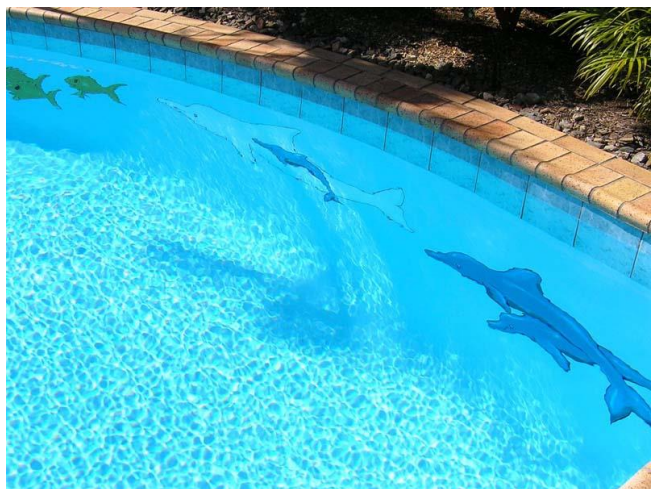
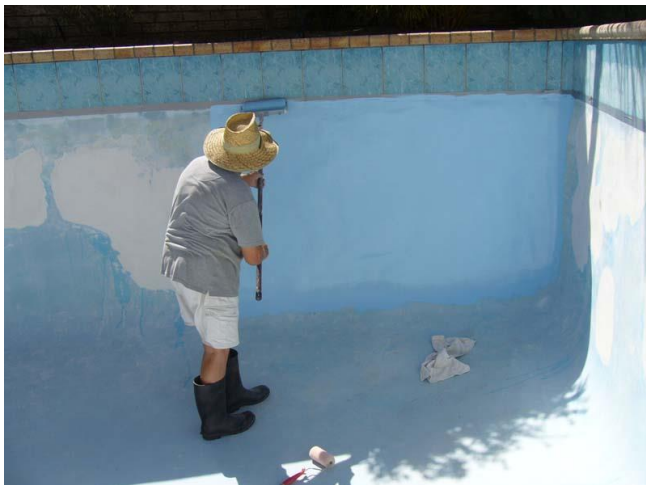
Undertaking repairs to Marcite, through to finished pool.

- Empty pool and look closely at surface.
- Check for drummy and soft / weak areas – remove & replace.
- Check for rust spots and if from below, deal with corrosion of pool structural steel work thoroughly.
- Algae roots need to be killed with algacide
- Calcium residues need to be removed.
- Any missing, worn or rough areas should be filled before painting.
- A thorough clean to remove all fats, dirt and loose particles.
- Apply 1 – 2 coats of a sealer coat E2100
- Apply 1 coat of a bodycoat, E4115 (if needed to smooth the surface)
- Apply 2 coats of PaintnForget V790 for a seamless, easy clean, long-lasting finish.
